Monthly Oversight Report 23
ACS NPL Site
Griffith, Indiana
November 2, 2002 - November 29, 2002

Subject: Monthly Oversight Summary Report
No. 23 for November 2002

Monthly Oversight Summary Report No. 23
ACS Superfund Site WA57, 46526.238

Reporting Period: Month of November (November 2, 2002 - November 29, 2002)

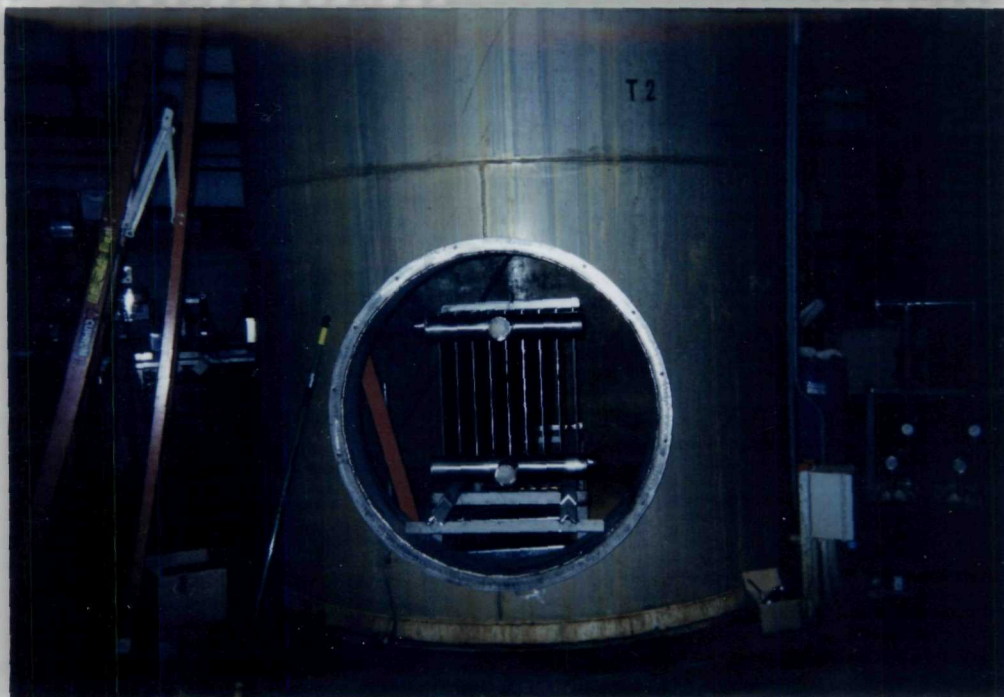
0735 Roll 31 Photo 18 facing NW in GWTP showing heat exchanger in tank T-2.

Site: American Chemical Services, Inc.
 Proj. #: 46526
 Roll: 31 Photo #18
 Date: 11-05-02 Time: 07:35
 Photographer: Leigh Peters
 Description: Photo facing northwest in GWTP showing
 the heat exchanger installed at the base of
 tank T-2.

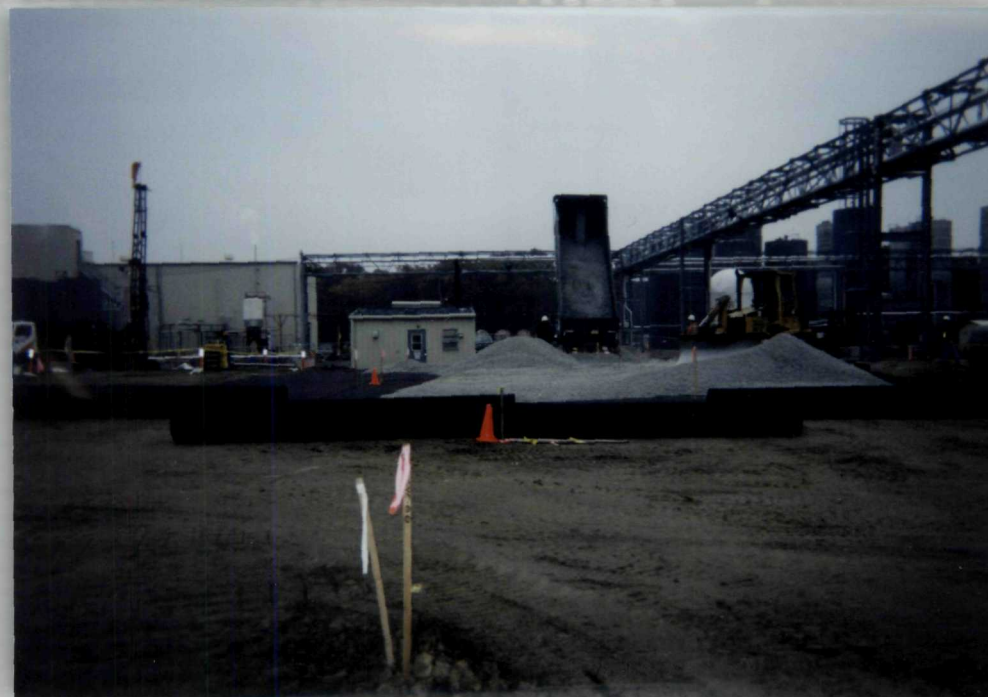
0810 Roll 31 Photo 19 facing N showing road, gravel and AS point.

Site: American Chemical Services, Inc.
 Proj. #: 46526
 Roll: 31 Photo #19
 Date: 11-05-02 Time: 08:10
 Photographer: Leigh Peters
 Description: Photo facing north showing HHSI installing
 the gravel road located on the central
 portion of the SBPA.

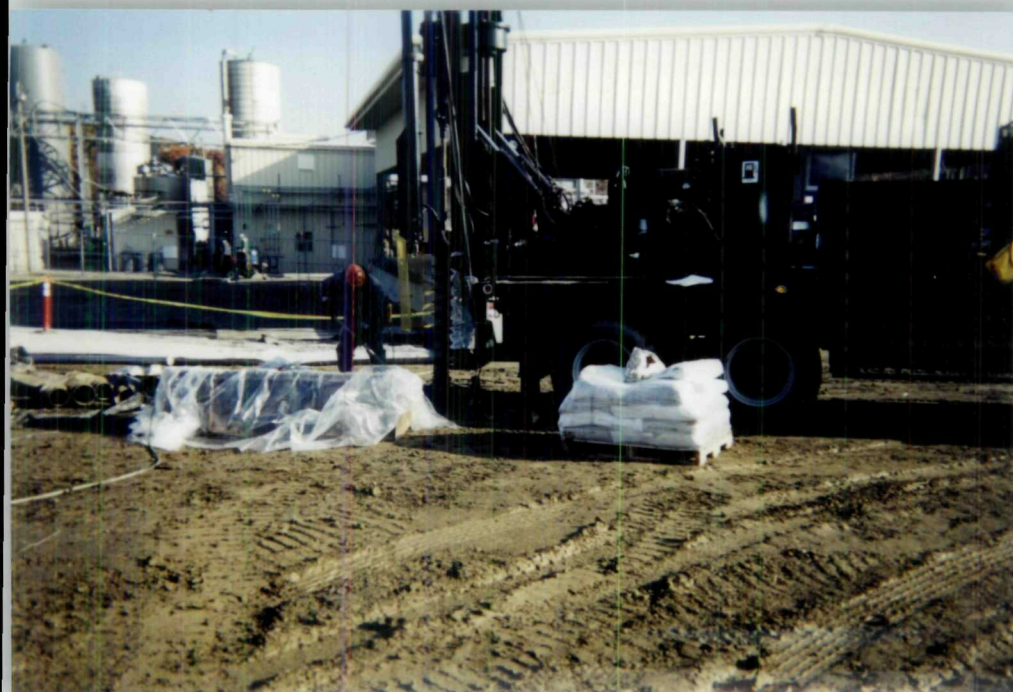
0900 Roll 31 Photo 24 facing N showing BLA drill SVE-59 - 4-inch screw well.

Site: American Chemical Services, Inc.
 Proj. #: 46526
 Roll: 31 Photo #24
 Date: 11-07-02 Time: 09:00
 Photographer: Leigh Peters
 Description: Photo facing north showing BLA drilling
 ONCA ISVE well SVE-59.

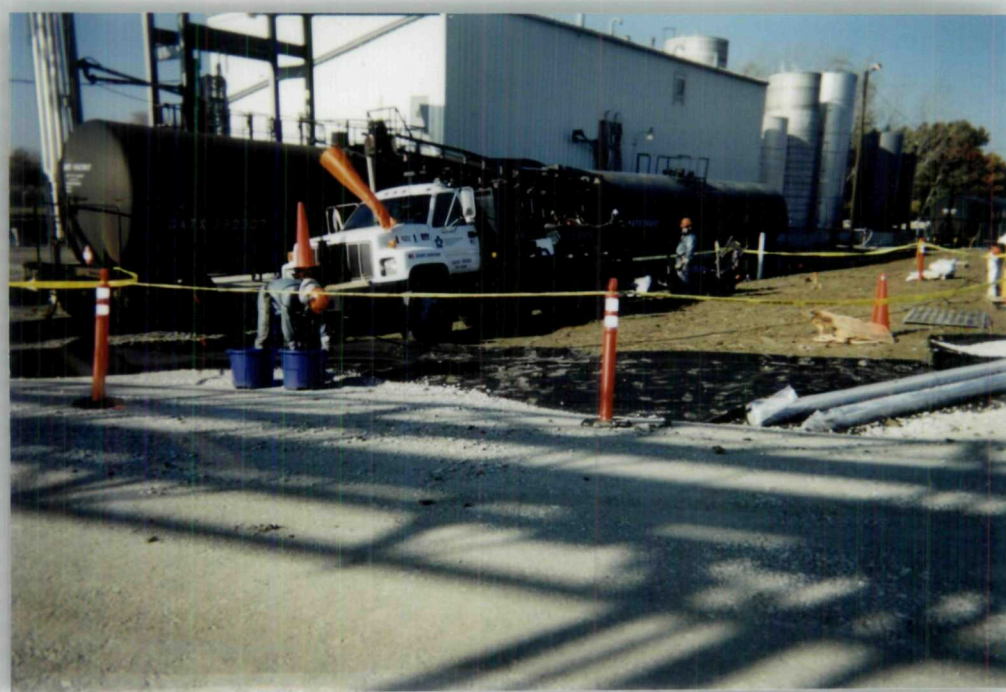
0940 Roll 31 Photo 25 facing SW showing BLA exclusion zone and decontam at SVE-80.

Site: American Chemical Services, Inc.
 Proj. # 46526
 Roll: 31 Photo #25
 Date: 11-07-02 Time: 09:40
 Photographer: Leigh Peters
 Description: Photo facing southwest showing BLA
 deconning at the perimeter of the exclusion
 zone at ONCA ISVE well SVE-80.

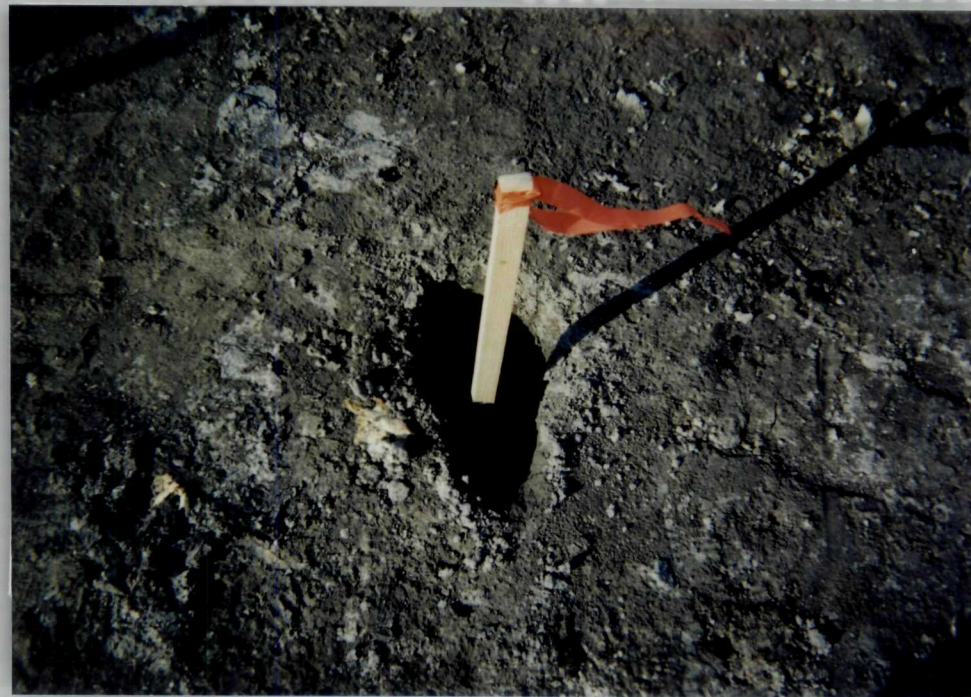
H+S: no incidents until this morning - Area Survey personnel stepped where hole abandoned + twisted knee - to see doctor and stopped work. BLA to mark location and will run over any abandoned holes to ensure that they are stable. Pump seal leaking at scrubber - slightly acidic pH. BLA + MNH did not have H+S documentation for a BLA personnel. MNH was not aware and will pay better attention.

Description: Photo facing south at ground showing a backfilled borehole.

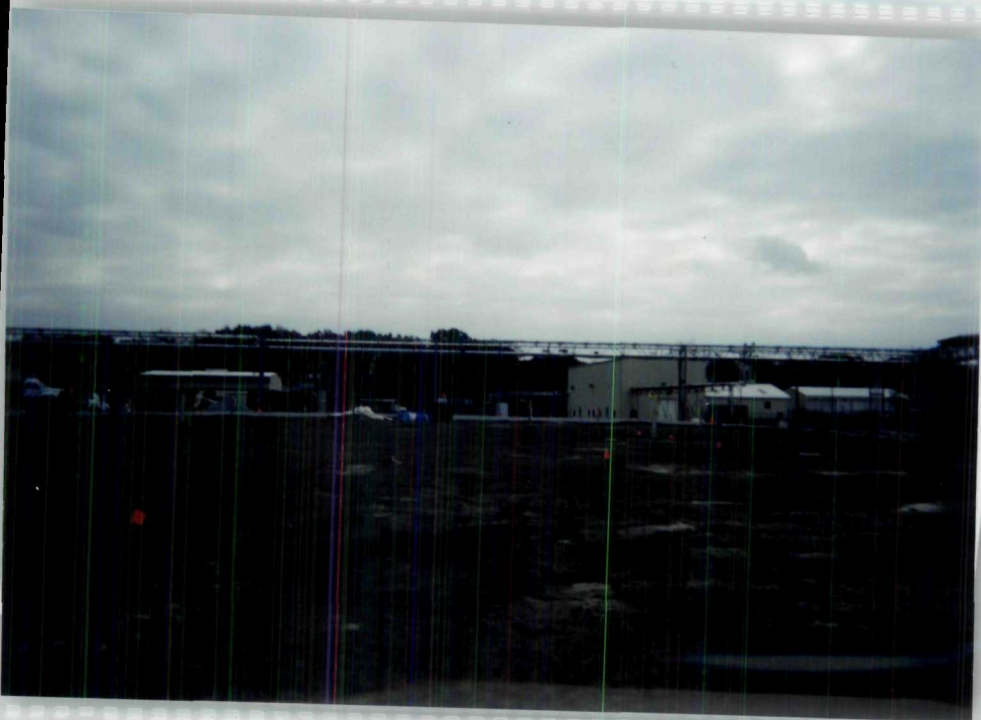
1015 Photos 5+6 Roll 32 facing east. Photos of ONCA cap standing on west edge of cap. Photo 5 is North portion; photo 6 is South portion.

Site: American Chemical Services, Inc.
 Proj. #: 46526
 Roll: 32 Photo #6
 Date: 11-12-02 Time: 10:15
 Photographer: Margaret Clark
 Description: Photo facing east showing the ONCA interim cover.

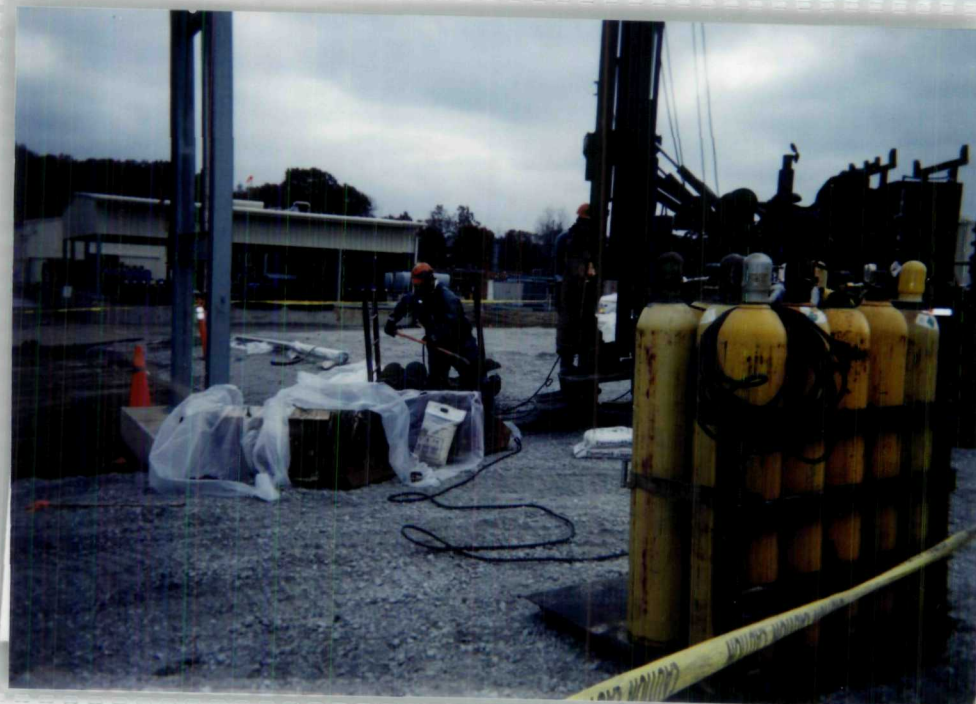
1300 Photo 7 Roll 32 Facing SE - photo of BLV drilling @ SVE 48.

Site: American Chemical Services, Inc.
 Proj. #: 46526
 Roll: 32 Photo #7
 Date: 11-12-02 Time: 13:00
 Photographer: Margaret Clark
 Description: Photo facing southeast showing BLA drilling ONCA SBPA ISVE well SVE-48.

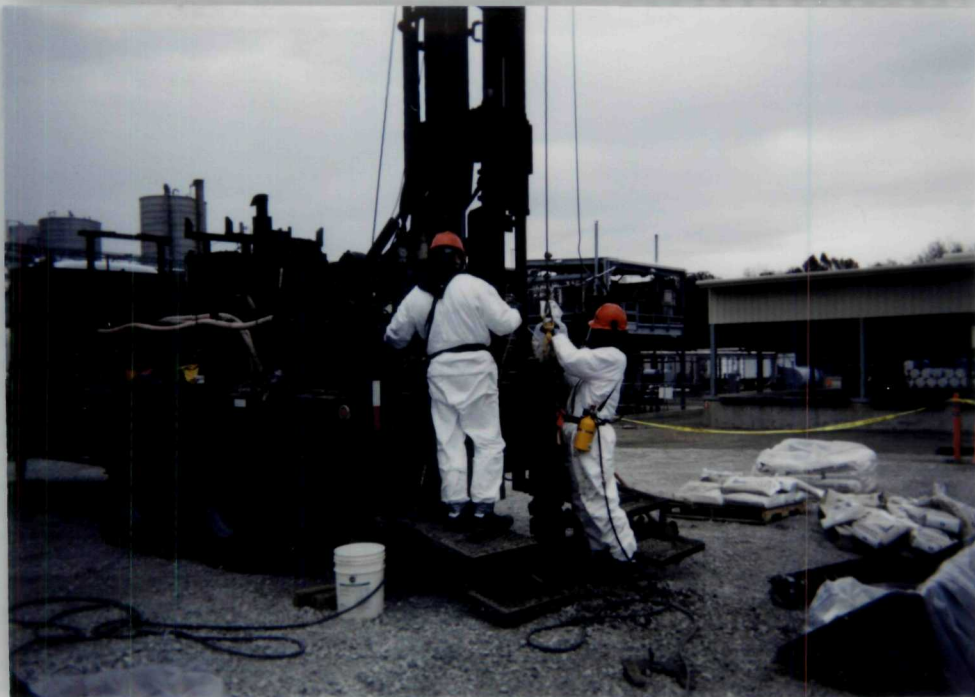
- 0735 Spoke with L. Orosz - he reported
IES exposed damaged 3" ϕ line
yesterday but could not repair
because of rain. Will repair this
morning and pressure test.

- 0750 Roll 32 Photo 14 facing northwest
showing damaged 3" ϕ pipe at SVE46
tee and air sparge point
- 0755 Roll 32 Photo 15 facing NW of
IES monitoring excavation with PID -
no readings.

Description: Photo facing northwest showing the damage to the 3-inch-diameter groundwater conveyance piping located near ONCA SBPA ISVE well SVE-46.

- 1000 IES completed fusing the pipe repair. IES
to start pressure test in 15 min.
- 1010 Roll 32 Photo 19 facing SW of Ryan
placing concrete blankets at future blower
shed on ONCA.

1040 Observed IES pressure test 3-inch ϕ water conveyance pipe for 15 min at 20 psi. - Line not holding 20 psi, IES looking at fittings to see if leak at SVE-46. MWH reported that there was a second location where BLA may have hit the line - IES to investigate. IES does not observe the leak at SVE-46 repair. IES to move to next suspect location to search for leak. IES won't be able to start tapping into wells until 3-inch ϕ line is pressure tested. IES observed air and water bubbling at SVE-87; to excavate at 87 for repair. IES to not start tapping into wells until next week.

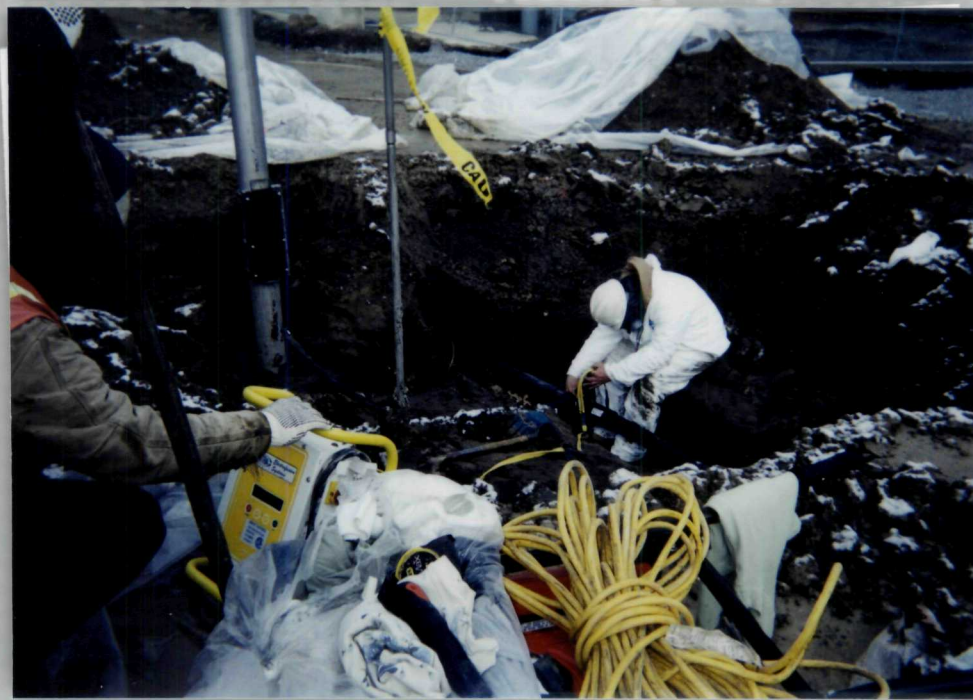
- 0900 Roll 32 Photo 17 of IES scanning coupling
for electrical fusing of pipe.
- 0930 Spoke with L. Orosz - he reported that the
geotextile for under blower shed foundation
can't be delivered today. MWH to check if
IES has tube, if not, MWH can't set the
stub-ups at blower shed. Ryan Construction
to bring concrete blankets to lay at
shed foundation to keep ground from freezing
in order to pour concrete next week.

Description: Photo facing northwest of IES scanning the coupling to weld the HDPE piping.

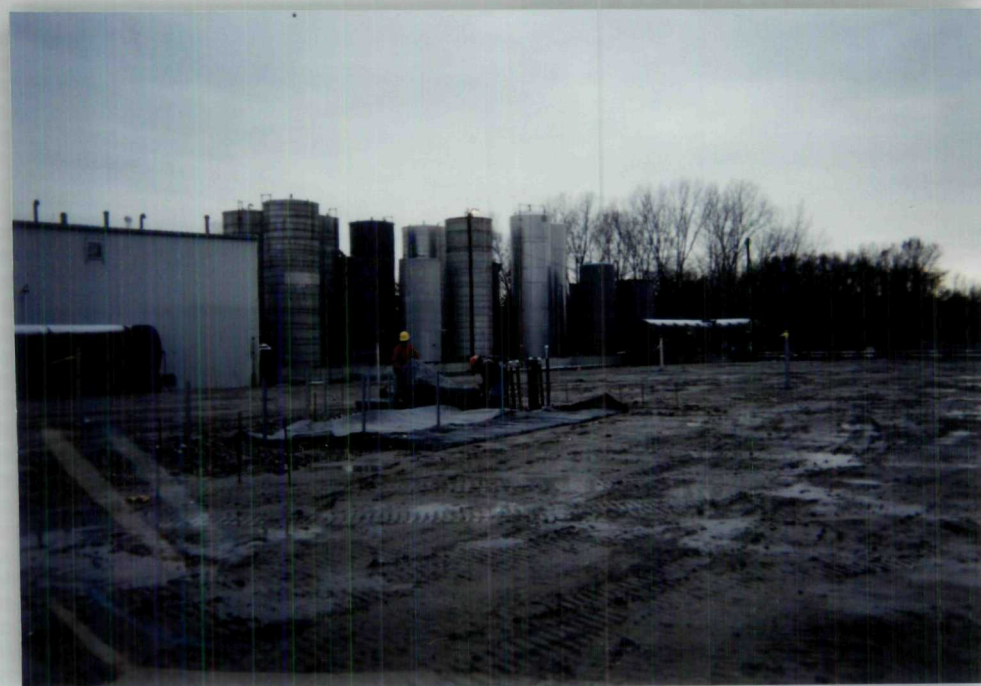
Roll: 32 Photo #19

Description: Photo facing southwest showing Ryan Construction placing concrete blankets at the location of the future ONCA SBPA ISVE system blower shed.

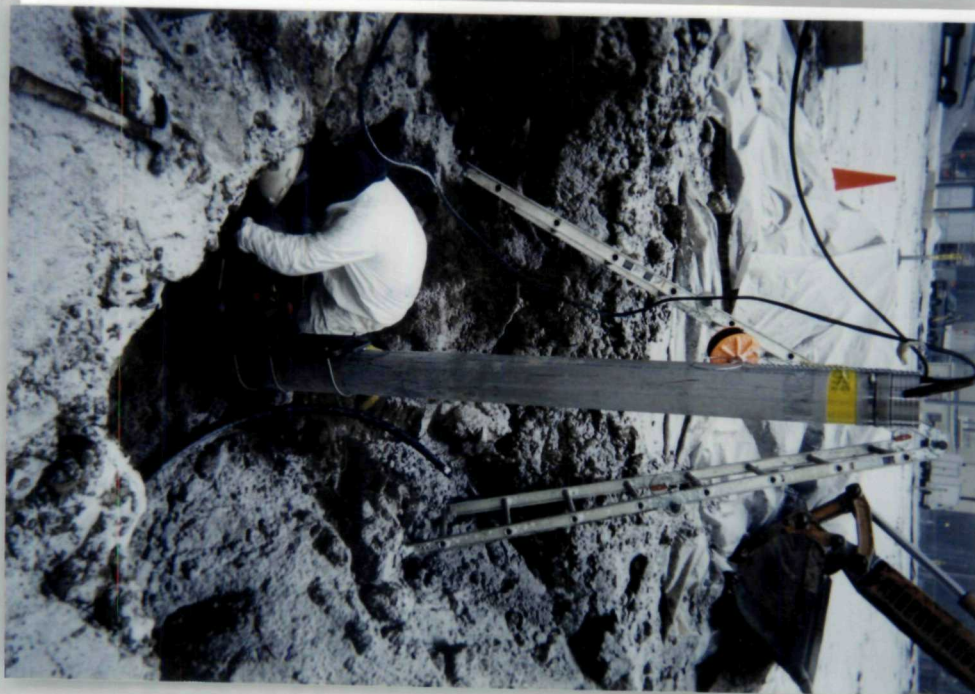
Roll: 32 Photo #20

Description: Photo facing west showing IES drilling the 1 3/4-inch-diameter hole for the water conveyance piping connection at ONCA SBPA ISVE well SVE-87.

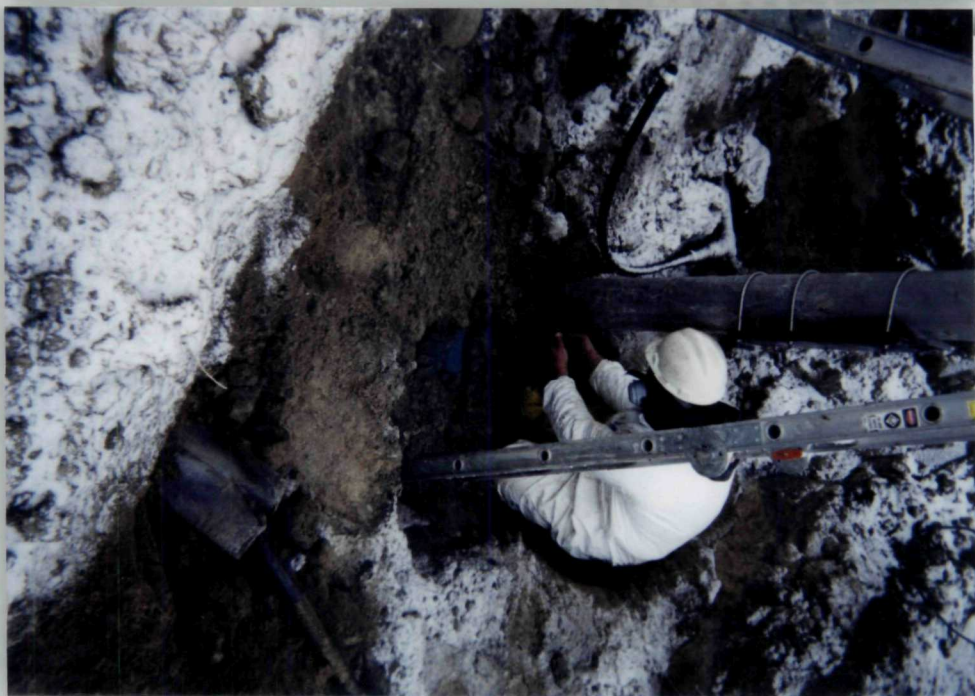
Roll: 32 Photo #24

Description: Photo facing southeast showing the installation of the washer and the nut used to secure the pitless adaptor.

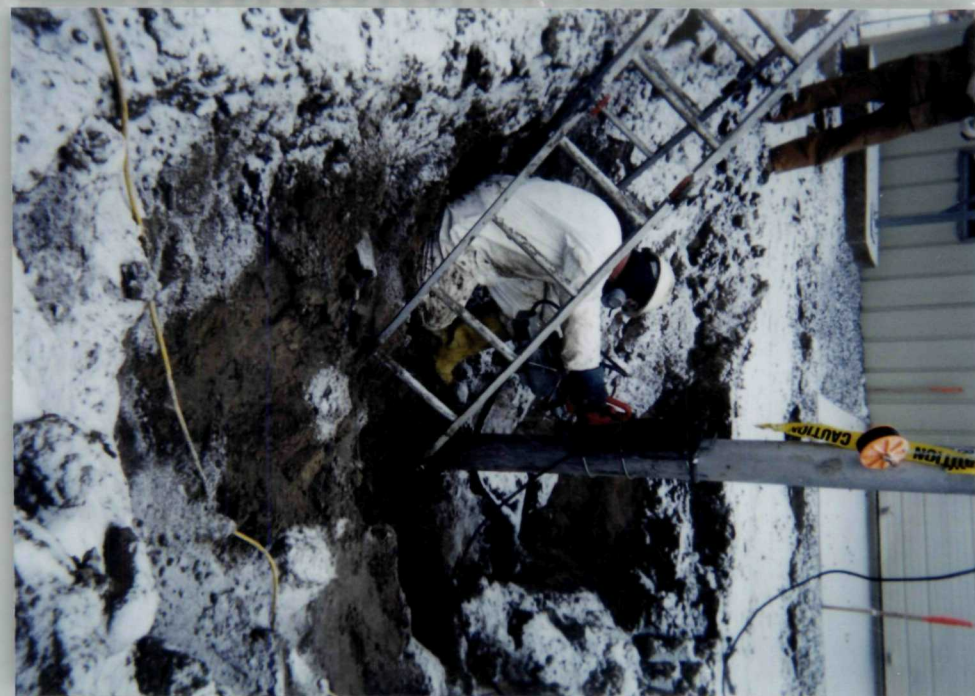
Roll: 32 Photo #25

Description: Photo facing east showing IES drilling the 3-inch-diameter hole for connection to the vapor conveyance piping in ONCA SBPA ISVE well SVE-87.
